**BOARD OF PILOT COMMISSIONERS FOR THE
BAYS OF
SAN FRANCISCO, SAN PABLO, AND SUISUN**

**INCIDENT REVIEW COMMITTEE
INVESTIGATION REPORT**

**REPORT OF THE INTERACTION BETWEEN THE M/V JIANGMEN TRADER
AND THE M/V STRATEGIC ALLIANCE WHILE PASSING BERTH #6, PORT OF
PITTSBURG, ON JULY 23, 2020
PILOTS: CAPTAIN KRIS LAAKSO AND TRAINEE DAN MURNEY**

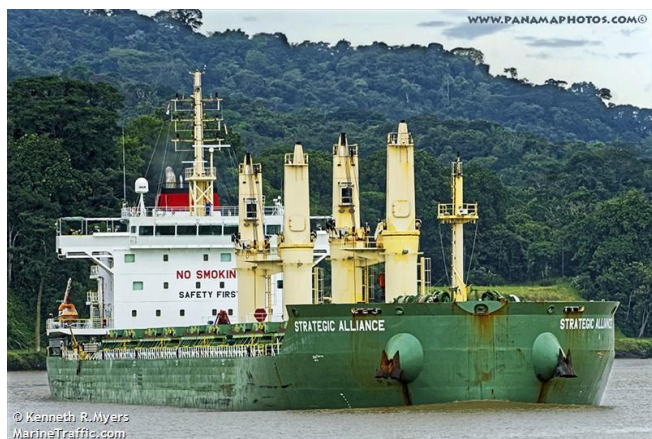
Vessel Particulars:

Length: 590 feet Beam: 98 feet
Design Draft: 35 feet deep
Tonnage: 39,848 gross tons
Propulsion: Diesel Engine
Owner: SBC Alliance Pte Ltd.
Operator: Maritime Management Group

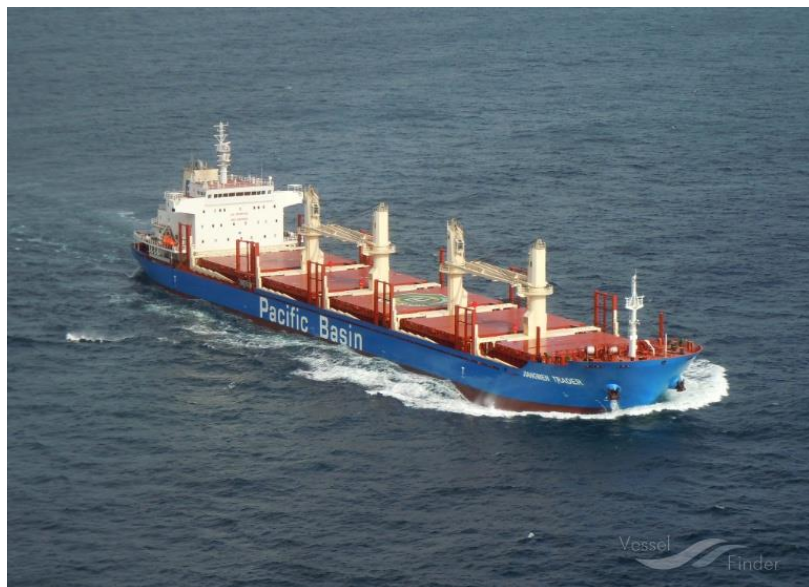
The JIANGMEN TRADER is a bulk carrier registered in Hong Kong, China. She was built in 2013.

Vessel Particulars:

Length: 587 feet Beam: 98
Design Draft: 34 feet deep
Tonnage: 37,673 gross tons
Propulsion: Diesel Engine
Owner: Jiangmen Trader Ltd.
Operator: Pacific Basin Shipping Limited
